CASE STUDY WITH A FIRE ORIGIN AND FIRE CAUSE REMOTELY LOCATED FROM THE ROOT CAUSE OF THE FAILURE IN A COMMERCIAL VEHICLE

Douglas R. Stahl, PE, CFEI/CVFI
Stahl Engineering & Failure Analysis, LLC, USA
and
Kerry D. Parrott, BSME, CFEI/CVFI, CFI
Stahl Engineering & Failure Analysis, LLC, USA

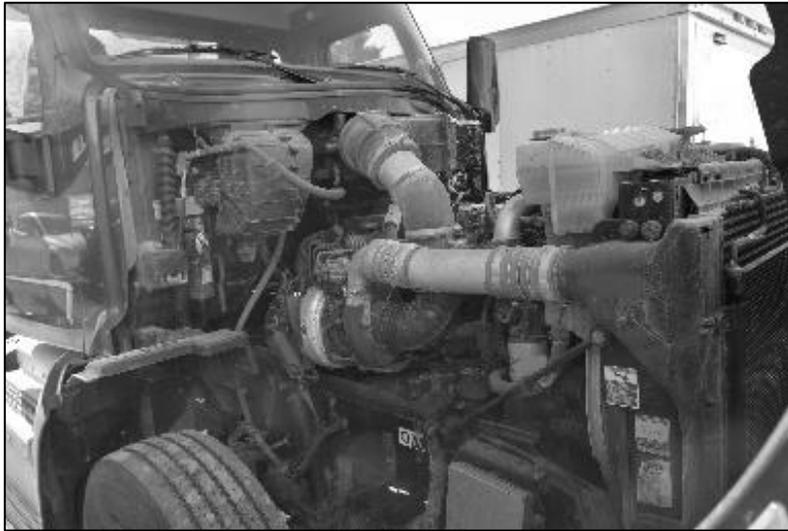
The area of the fire origin was determined through the witness account of the driver as the left/driver's side of the engine compartment (often referred to as the *cold* side of an in-line internal combustion engine, as the *hot* exhaust system components are typically grouped on the right side of the engine.) This witness account is consistent with the evidence on the inspected tractor showing the only fire damage present on the vehicle was located on the left side of the engine area, mostly inside the frame rail (Photo 2). With the hood open during the fire, there was little fire damage visible to the right side of the engine (Photo 3).

Photo 3 - Right Side Engine Compartment

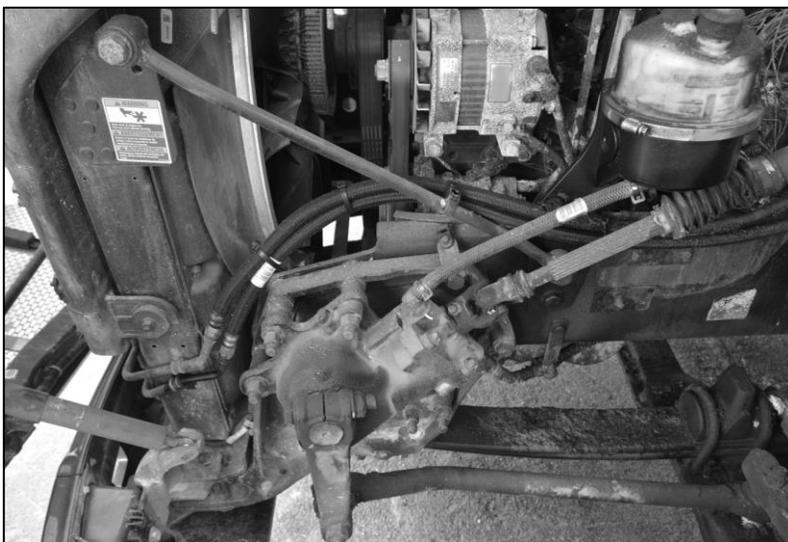
The area of the fire origin (Photos 4, 5) was examined for evidence relating to the cause of the fire. As NFPA 921 notes¹ fire cause determination is the process of identifying the first fuel ignited, the ignition source, the oxidizing agent, and the circumstances that resulted in the fire. The oxidizing agent is available air oxygen. There was a known prior leak of combustible power steering fluid potentially available as a first fuel, but an ignition source was initially lacking as there are normally no sources of sufficient temperature and heat for autoignition or competent sparks or arcs² for piloted ignition available on the left/driver's/cold side of the engine.

Photo 4 - Left Side Front Engine Compartment

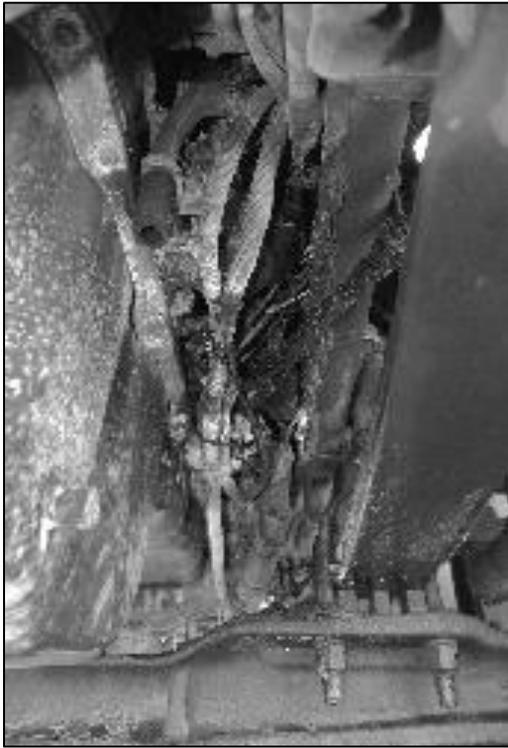
Photo 5 – Left Side Engine Compartment Underside Between Frame Rail and Engine

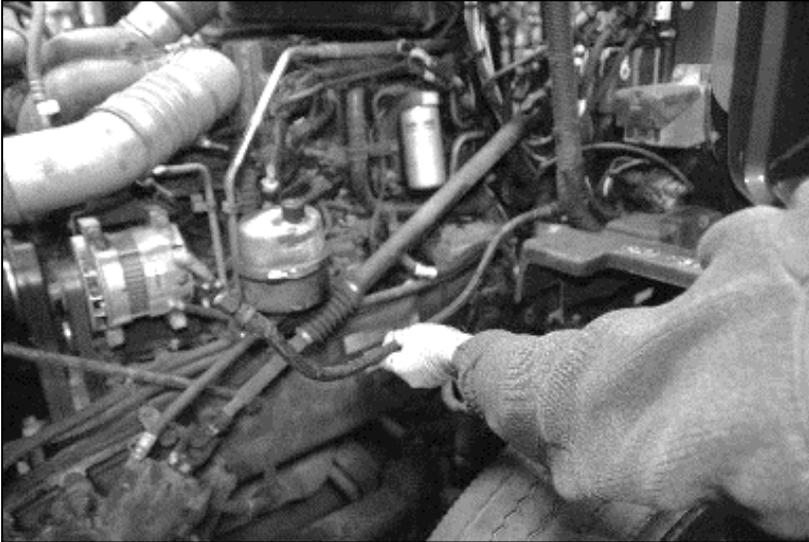
Inspection of the area of fire origin revealed no pertinent evidence indicating a possible cause except a power steering pressure hose with an anomaly that was removed for further examination (Photo 6). Further inspection showed a typical wire braid pressure hose that had lost integrity at a point, with the wire braid severed and failure of the inner liner, allowing the reported leak of the power steering fluid. This anomaly (Photos 7, 8) was located at the point of the rearward support clip for the hose with the clip attached to the engine (Photo/Schematic 9). Beads present at the severed braids on the hose wire braiding were magnetically confirmed to be steel (Photo 10). A mechanical failure of the hose and clip protective coverings would only potentially result after a long period of wear, eventually resulting in a hose leak, (if not noticed during periodic service inspections) but would not display the beading of the wire braiding present in the subject hose failure.

Photo 6 - Power Steering Hose Removed from Under and Inside Frame Rail – shown with Routing Displaced Upward and Outward

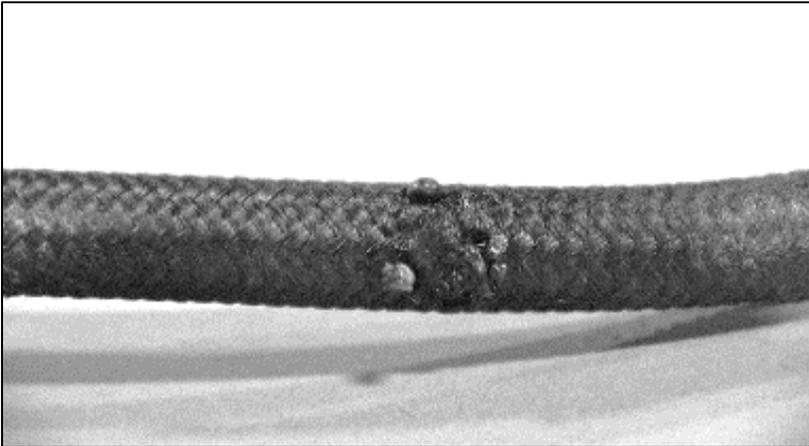
Photo 7 - Power Steering Hose Failure of Steel Wire Braiding with Beading

The only possible highly localized source of heat available to heat and sever the wire braid and create the beading of the steel wire braid would be an electrical potential between the hose support clip and the wire braid of the pressure hose. The electrical shorting occurred at that point when the outer covering of both the hose and clip had softened/melted sufficiently to allow the contact and subsequent shorting between the metallic clip and wire braid of the hose. This shorting between the clip and hose braiding was apparently present for some time prior to the fire, resulting in the leak of power steering fluid for which the tractor-trailer was stopped awaiting repair. No anomalies were found in any of the electrical wiring in the area of fire origin outside of normal fire/heat damage.

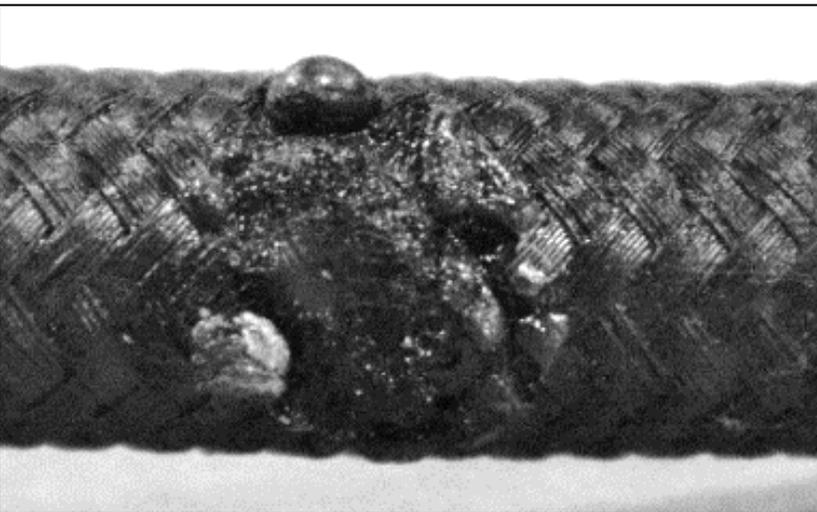
Photo 8 - Closeup of Power Steering Hose Failure of Steel Wire Braiding with Beading

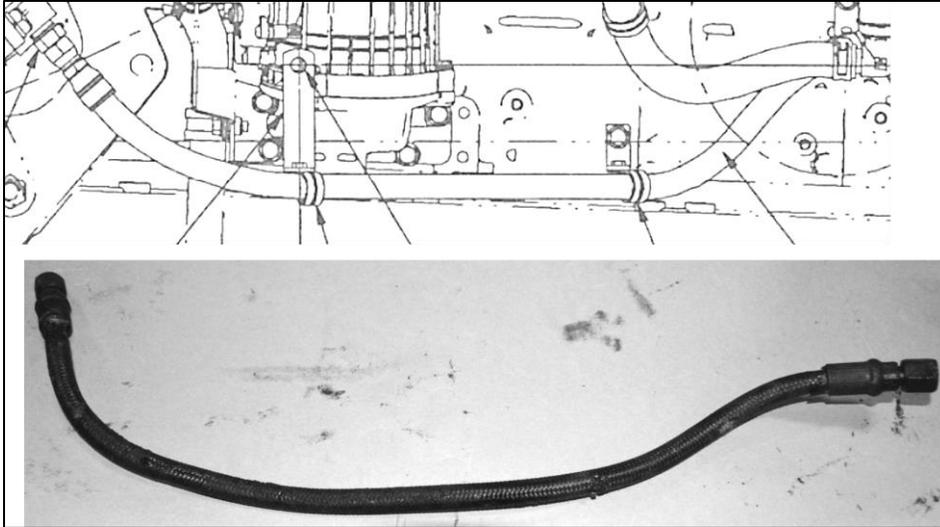
Photo/Schematic 9 - Power Steering Hose with Failure Location at Rear Support Clip

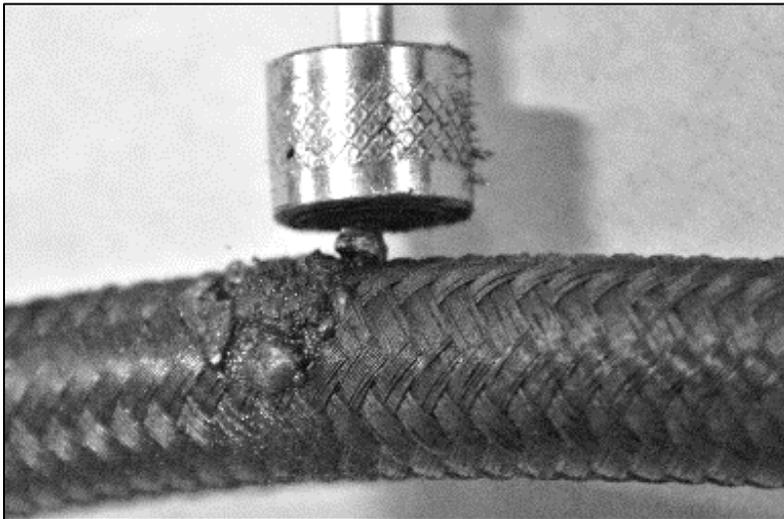
Photo 10 - Power Steering Hose Failure of Steel Wire Braiding with Beading and Magnet

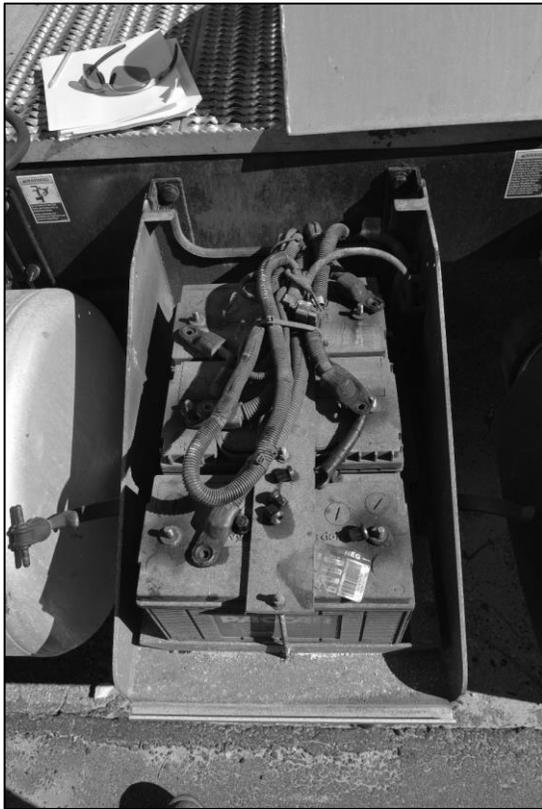
Further examination of the electrical system, outside of the area of fire origin (or fire damage), was performed and evidence was found in the battery box of shorting of the positive battery cables to the hold-down post securing the batteries (PHOTOS 11,12) - though exhibiting limited thermal damage without evidence of any fire. The battery hold-down post, which is normally part of the electrically common negative side of the truck, once shorted to the positive battery cable then creates an electric potential to other components, creating unintended electrical circuits eventually resulting in the unintended electrical activity between the power steering hose support clip and the wire braiding of the hose. The limited thermal damage evident in the battery box cannot be an effect of the fire in the engine compartment, but the engine compartment fire can be an effect of the shorting in the battery box.

Photo 11 - Battery Box – mounted left side frame rail behind cab

Supplied maintenance records indicated that all batteries had been replaced at least once in the tractor. Comparison of the battery cables' routing, clipping, and sheathing in the battery box show significant changes from the new/as-manufactured configuration of the cables at the time of the fire. The battery cables were no longer grouped and separated by polarity and secured and protectively sheathed as in the as-manufactured condition. Changes in the battery cable protection during service operations were determined to be responsible for the failure to protect the electrical power system in the battery box and directly led to the subsequent power steering leak and fire.

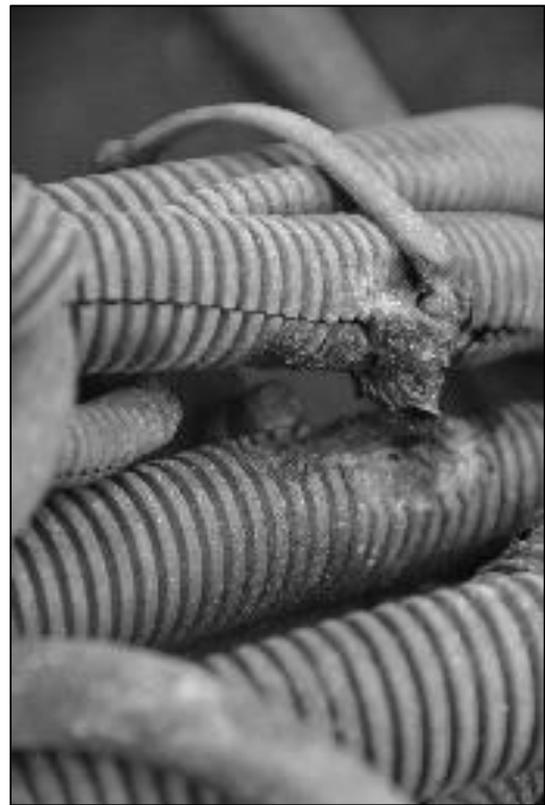
Photo 12 - Battery Cable at Hold-down Post

- c. The root cause of the failure that resulted in the fire was the shorting of a positive battery cable to a battery hold-down post within the battery box, with no fire damage and limited thermal damage in that area.
